## 1 TURBOCHARGER & CLAIM DETAILS

163597000006

## 2 SCOPE OF WARRANTY INSPECTION

## 3 INSPECTION FINDINGS

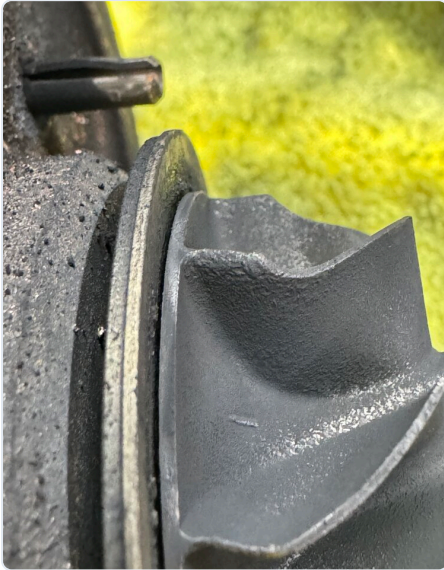
! **Turbine shaft / wheel - severe overheating and thermal damage.** The variable geometry components also show heat exposure and carbon contamination, which can restrict correct VNT operation.

**Fig. 1** - Turbine wheel / shaft area: visible heat-related surface damage.

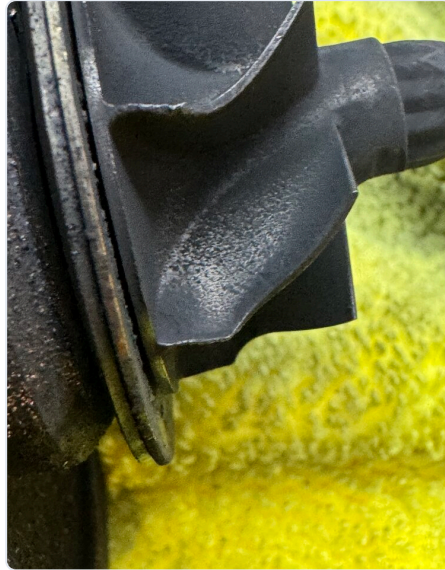
**Fig. 2** - Turbine wheel detail: abnormal surface condition and thermal exposure.

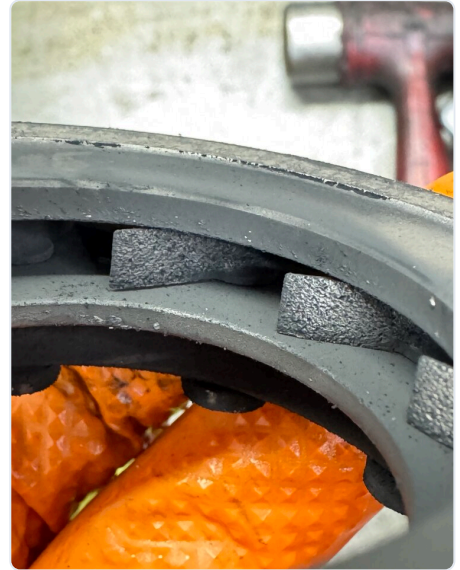
! **Turbine side and variable geometry mechanism - excessive thermal stress.** Heat discolouration and visible surface damage are consistent with operation at abnormally high exhaust gas temperature.

**Fig. 3** - Variable geometry components: heat exposure and discolouration.

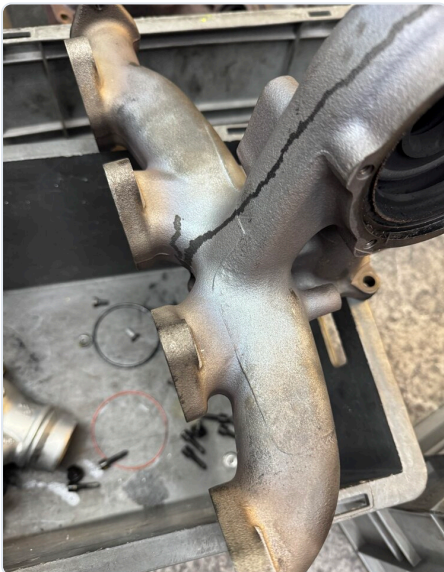
**Fig. 4** - Turbine / exhaust housing: evidence of excessive thermal loading.

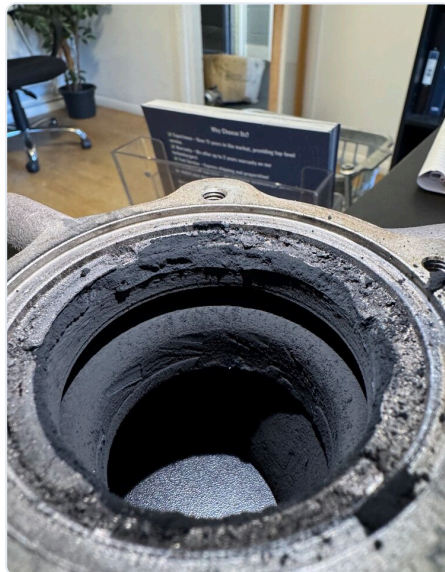
! **Very heavy accumulation of carbon deposits** within the turbine housing and exhaust gas passages. This level of contamination is abnormal and is consistent with restricted exhaust flow, excessive oil combustion, an engine combustion fault, or a combination of these conditions.

**Fig. 5** - Heavy carbon contamination inside the turbine / exhaust housing.

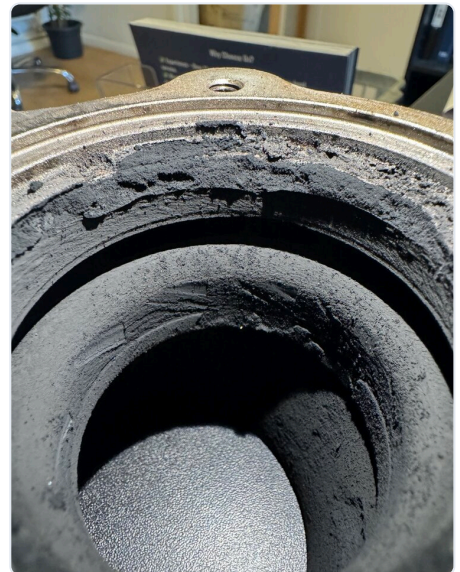
**Fig. 6** - Close-up of severe carbon accumulation in the exhaust gas passage.
